MALFUNCTION INDICATOR LAMP (MIL) MULTIPLE MOTOR POSITION SENSOR FAULTS STORED IN EME

F15 PHEV (X5 xDrive40e)

Procedure to inspect and repair the EME connector wiring harness: F15 PHEV

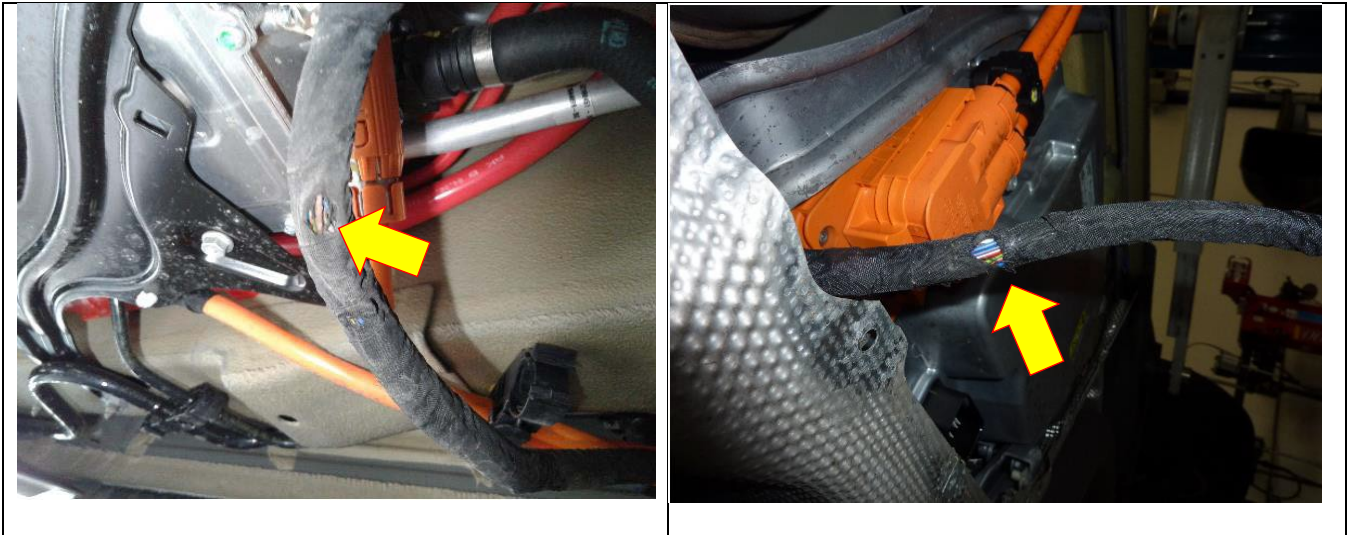
If there are chafe marks on the wiring harness (arrows) per the examples below, the harness must be repaired. Go to Step 3.

3. De-energize high-voltage system. Refer to Repair Instructions 61 25 900.
4. Disconnect the 12V battery. Refer to Repair Instructions 61 20 900
5. Remove the underbody paneling on the right side. Refer to Repair Instructions 51 71 016.

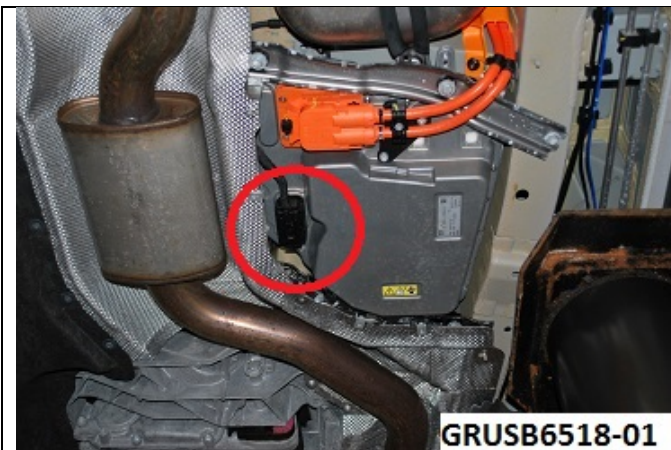
6. Perform a visual inspection of connector A190*1B on the bottom of the EME.

If there are noticeable problems (e.g. damage, traces of water, etc.) contact BMW of North America's Technical Service Department by submitting a PuMA case.

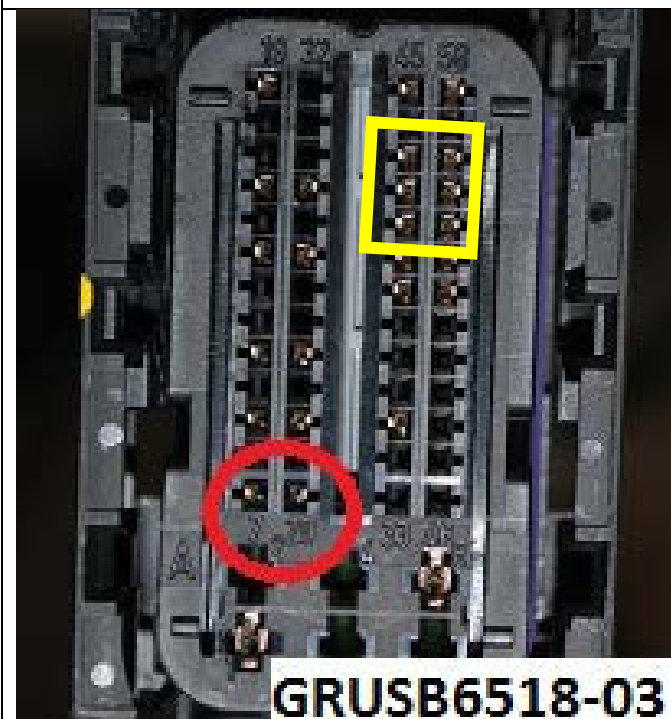
- Examine pins 41, 42, 43, 54, 55, and 56 at the EME connector (outlined in yellow)
- Also examine pins 7 and 20 (outlined in red) which are for the ACSM signal
- Submit a PuMA case if there is visual/water damage to these pins

9. Release the connector cover.

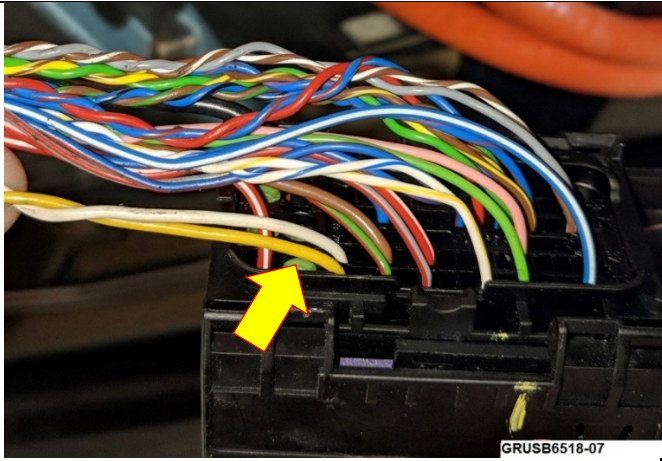
GRUSB6518-07

The two wires white and yellow are under strong tension, entering the connector at a tight angle (arrow).

10. Remove the last 8" of tape from the harness at the EME connector to reduce the pull tension of this connection at the EME.

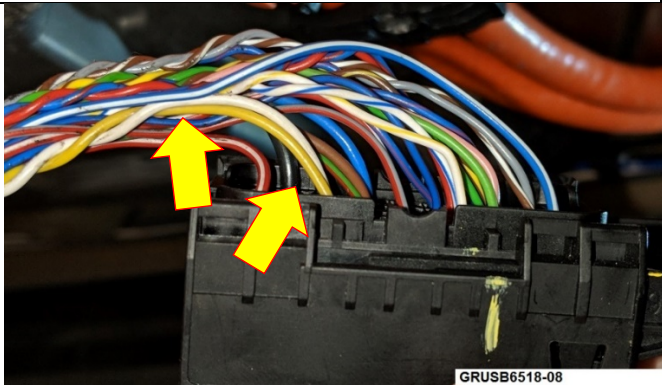
GRUSB6518-08

11. The wires between the cable tie location and the EME electrical connector/pins should **NOT** be under tension!

The white and yellow wires have been reformed in a larger radius (arrows) to enable a partial relief bend. This eliminates tension on the electrical pins.

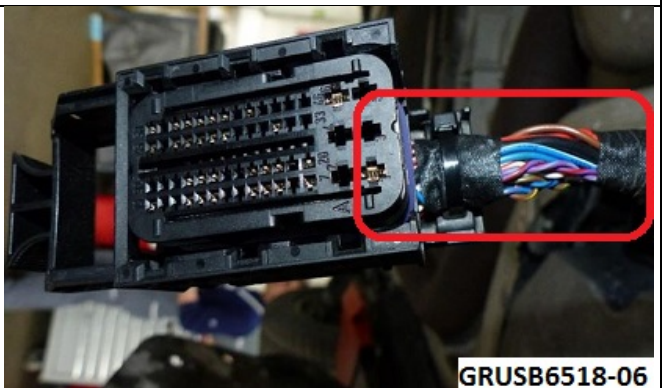
GRUSB6518-06

There should be a 2" or larger gap (circled) between this wrap for the cable tie, and where the harness' main wrap begins.

13. Wrap Fabric-tape (P/N 61 13 6 902 588) twice around the wiring harness at the location where the cable tie will be fastened.

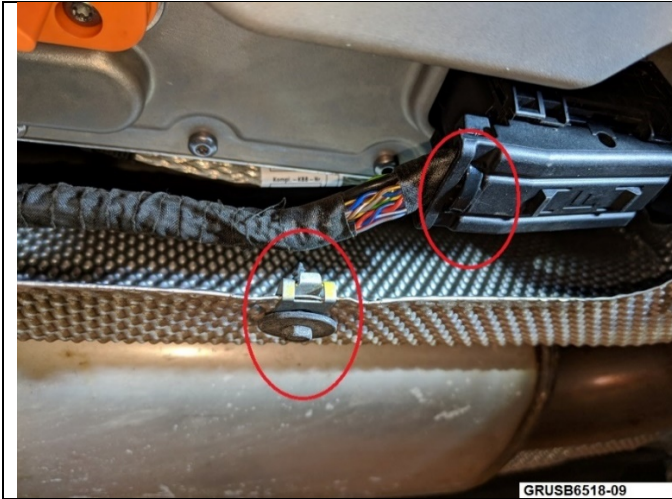
Also check to make certain there is minimal tension on the harness so that it won't droop and contact the tip of the underbody panel hold down screw (left circle).

14. When reinstalling the cable tie (P/N 61 13 1 367 599) on the end of the EME connector, point the end of the tie upwards so it can't rub on the underbody panel of the vehicle (right circle).
